AQUATIC LEASE INSPECTION REPORT

LEASE NUMBER: 22-A02332

USE: Marina

DATE OF INSPECTION: 2-13-2014

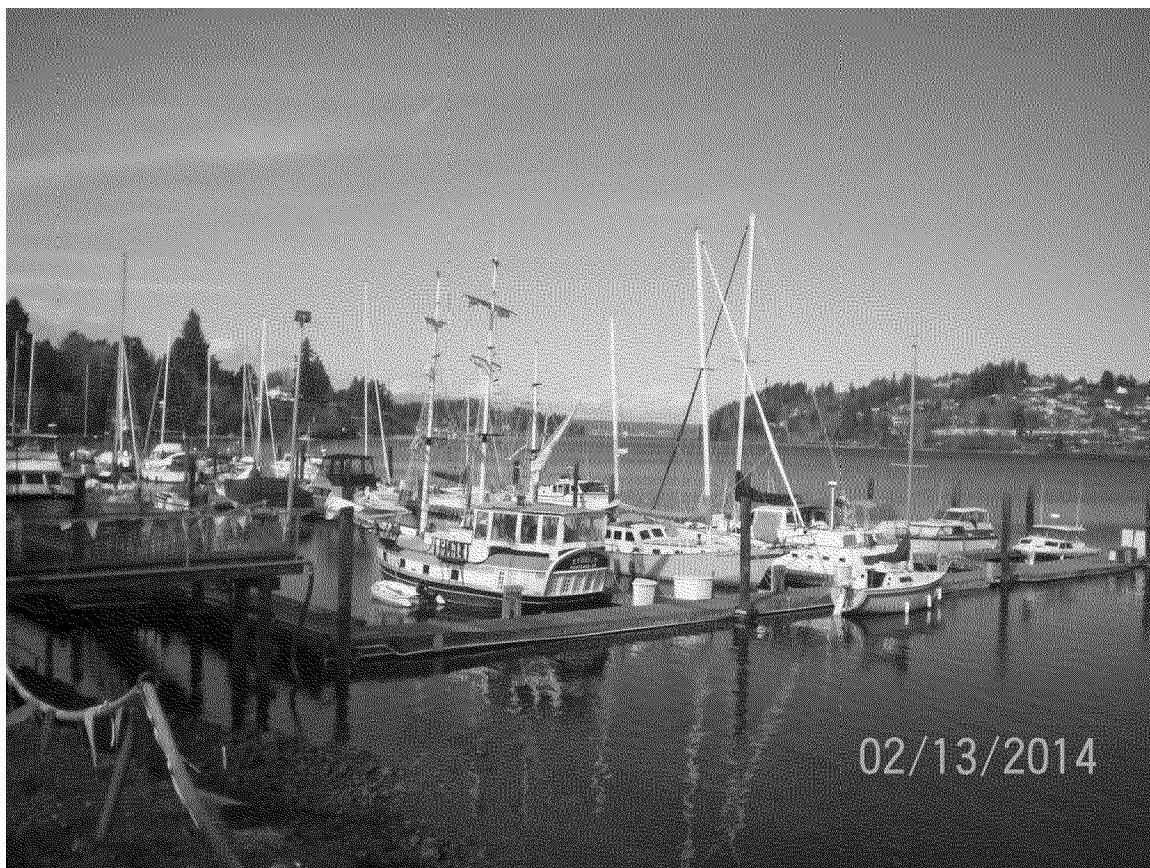
Figure 1 Picture of Marina from the parking area

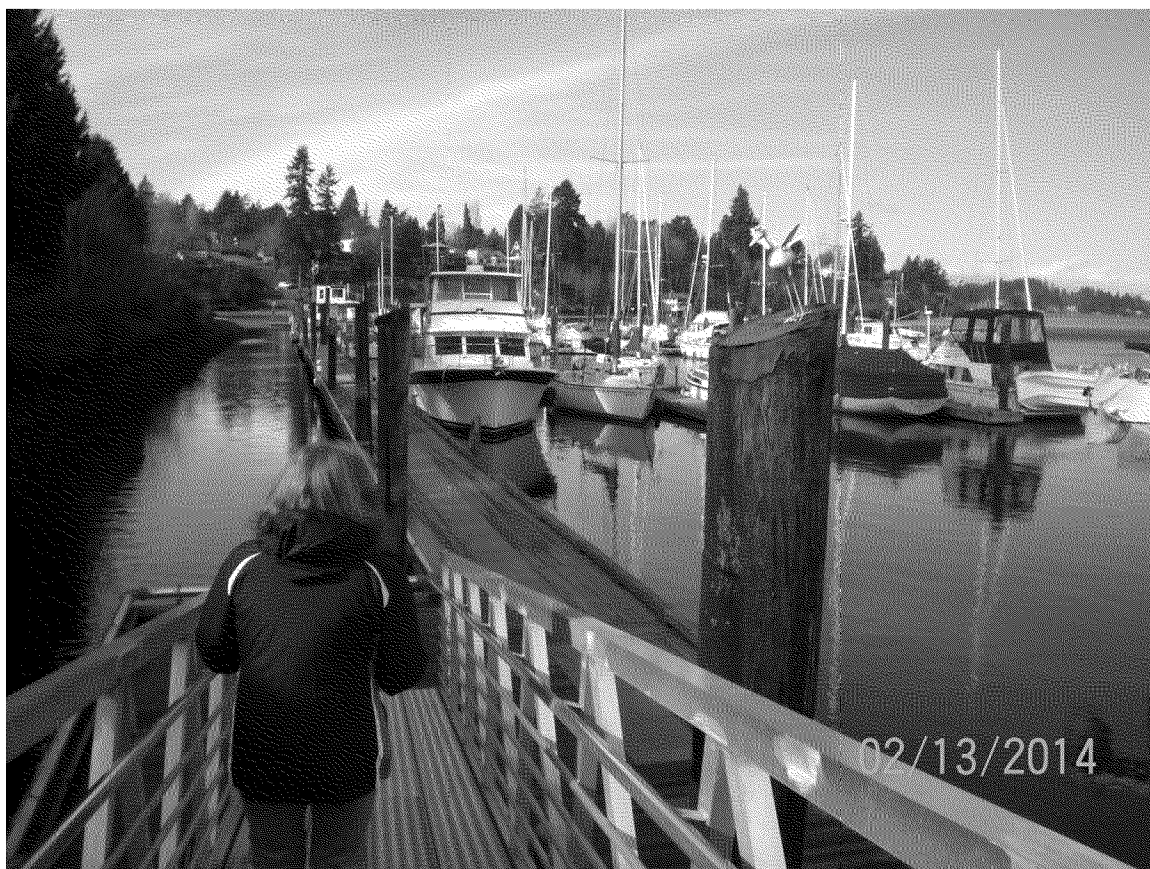
Figure 2 Metal Gangway from access pier to float system. Wood decks on float system

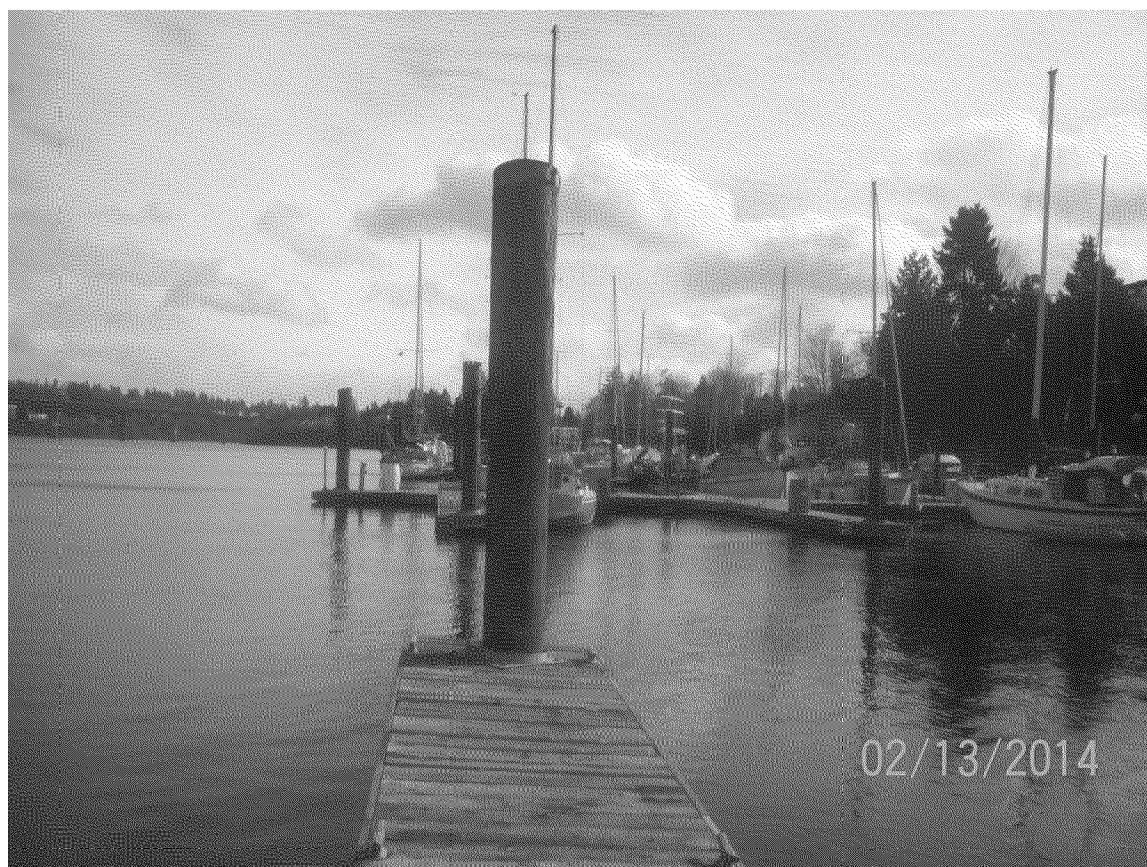
All moorage is within the harbor area. Vessels have been moved to the interior on Docks A & B. The moorage cleats have not been removed from Docks A & B.

Figure 3 Picture of the outside edge of the moorage floats. No vessels are tied to A or B dock.

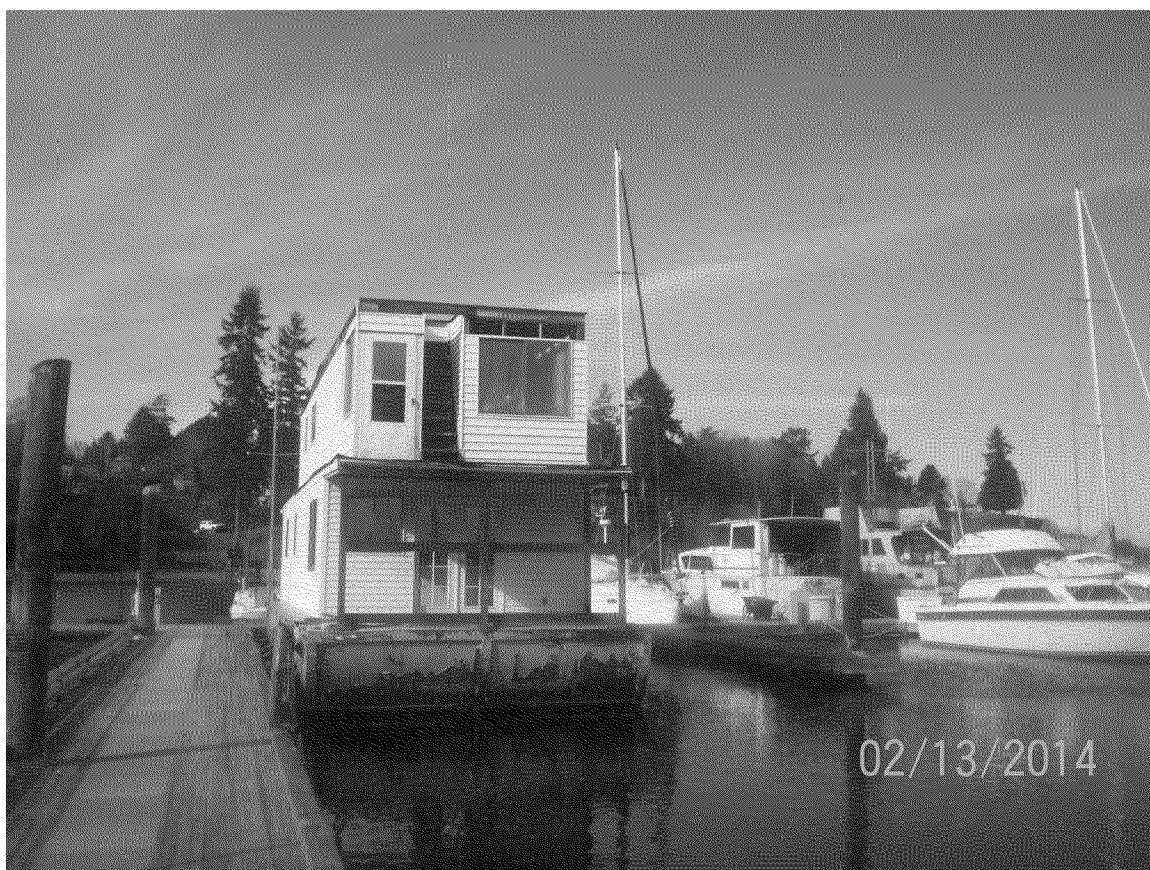
The derelict floating home remains in the marina. The marina took possession of the floating home and is in the process of removing debris from the interior. The decking on the barge has rotted away in places.

Figure 4 Derelict floating home

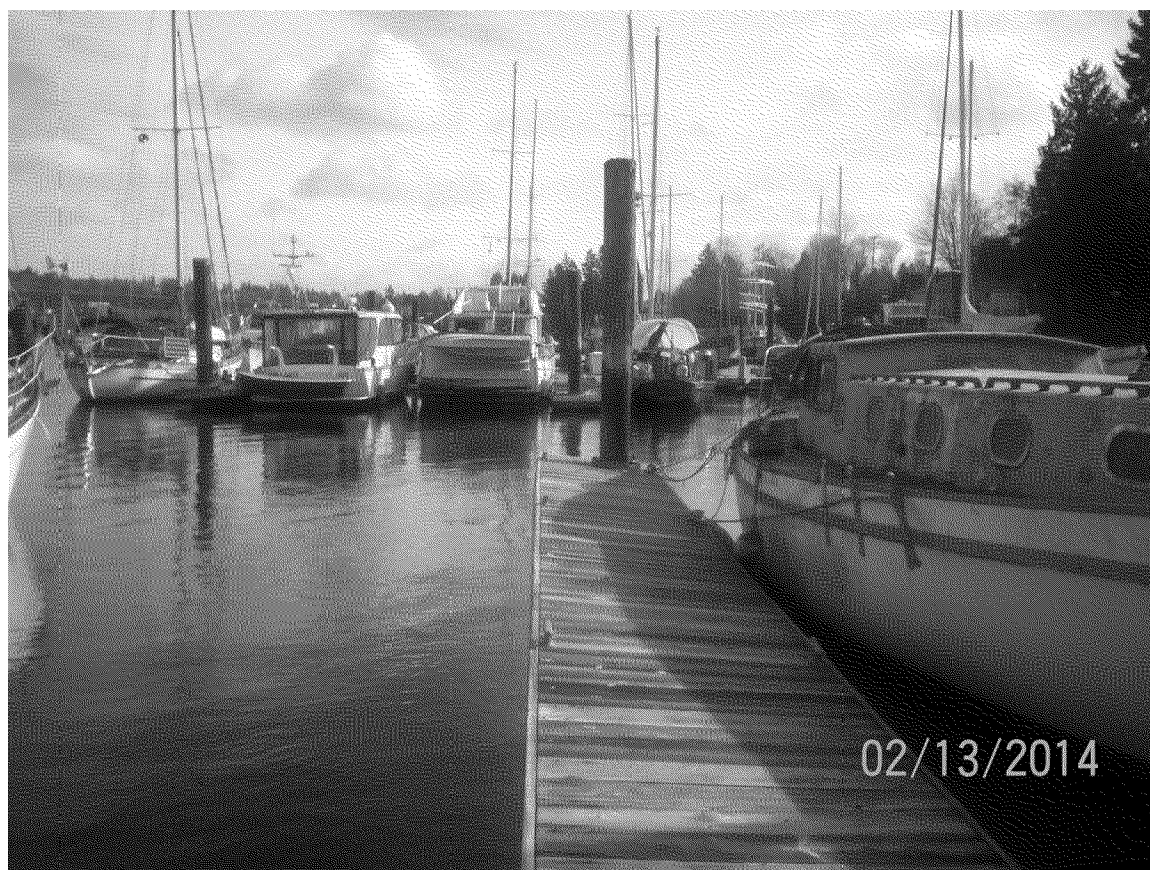
Some of the floats have been repaired. There are some floats which are still obviously listing. The pump-out is not operational. Restrooms and showers are available in one of the marina buildings. Tenants are still being directed elsewhere to pump their vessels.

Figure 5 Example of listing floats

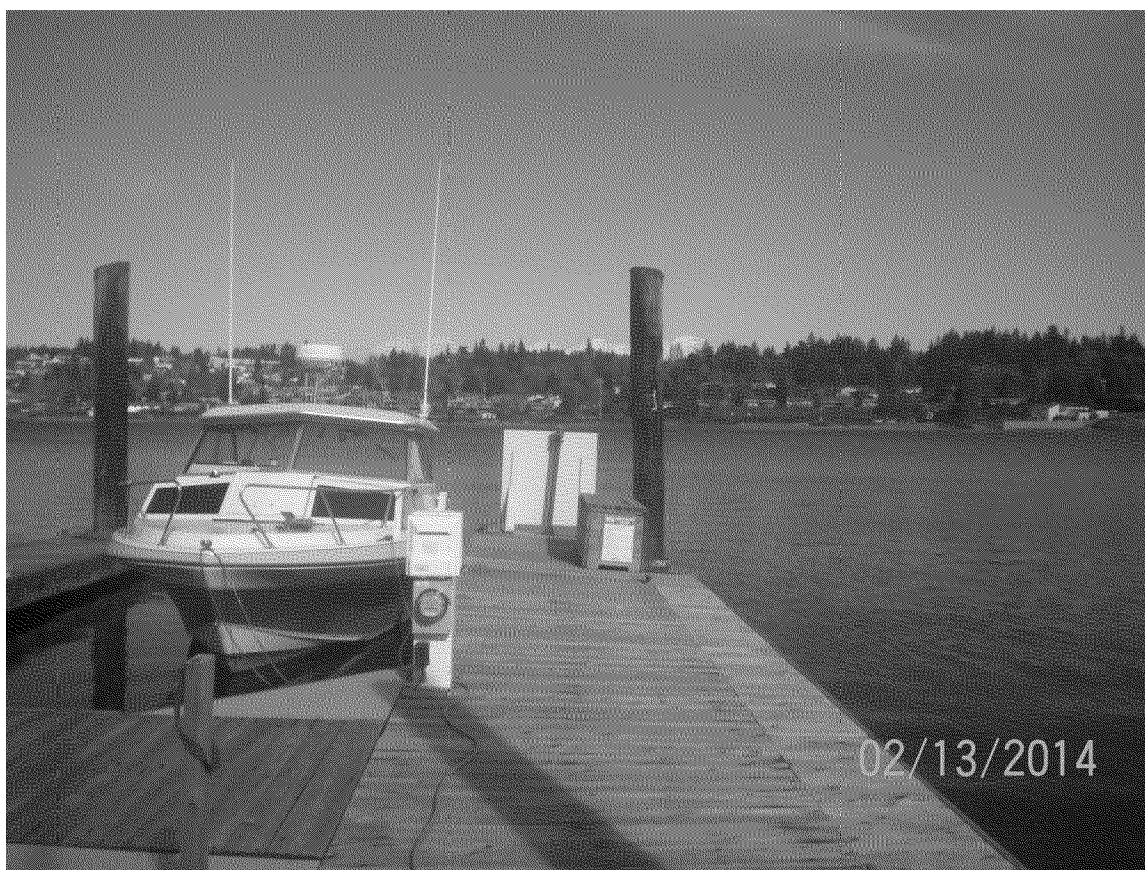
Figure 6 Pump out dock. Wood decking on the floats.
